Project final report

Investigation of the impact of ignition
of hydrogen and natural gas
accumulations in spaces in dwellings –
Phase 1
Kiwa 30875

10 August 2018

A report by Kiwa Ltd.

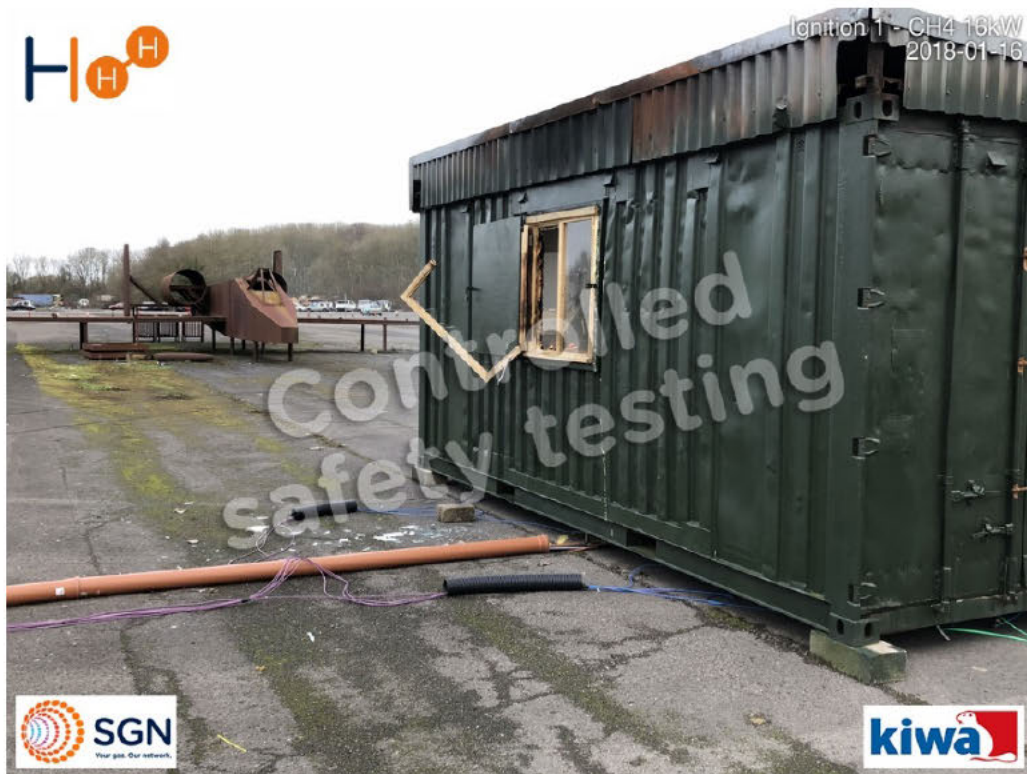
Figure 13: Outside view of FIB showing window above sink with detached frame and glass fallen out after ignition 1 (16kW methane)

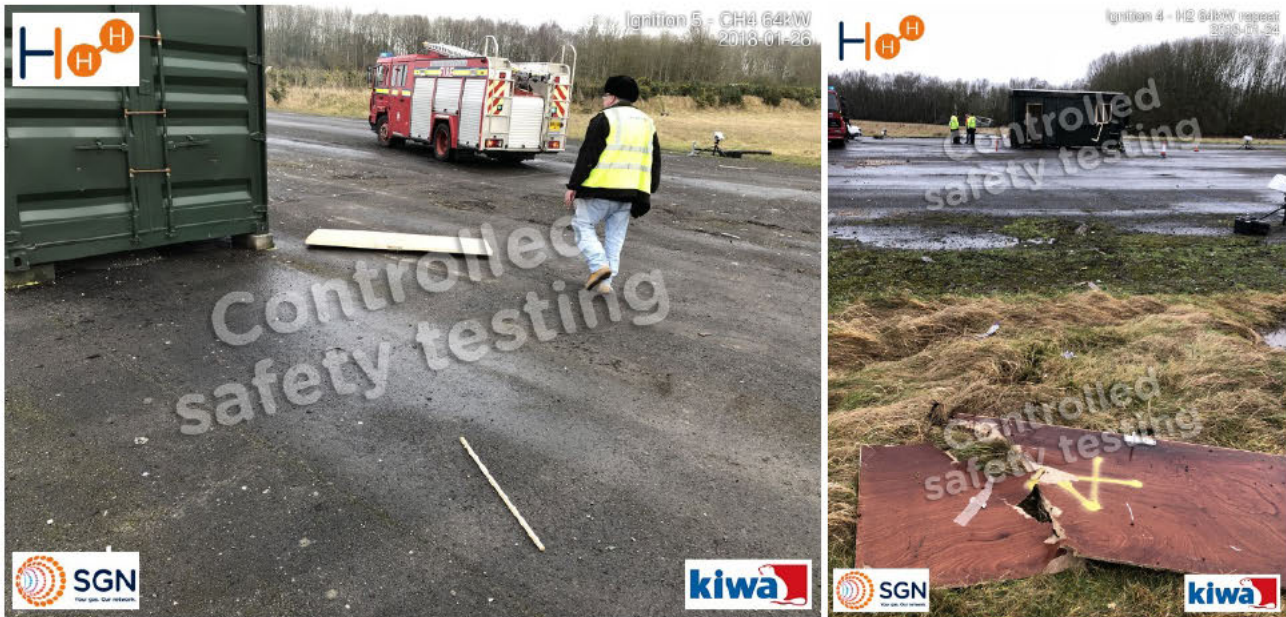
Figure 14: Blown out door and door surround
 Left: ignition 5 (64kW methane); Right: ignition 4 (64kW hydrogen with detonation)

Table 8 summaries the damage that was observed. In the smallest methane and hydrogen ignitions, the window frames were damaged and the windows opened, but the peak pressure was not sufficient to break the glass. In the larger ignitions for each of the gases, the glass was broken and the door was blown off its hinges. Ignition 4 (~64kW hydrogen) was sufficient to blow the entire door a distance of 25m.

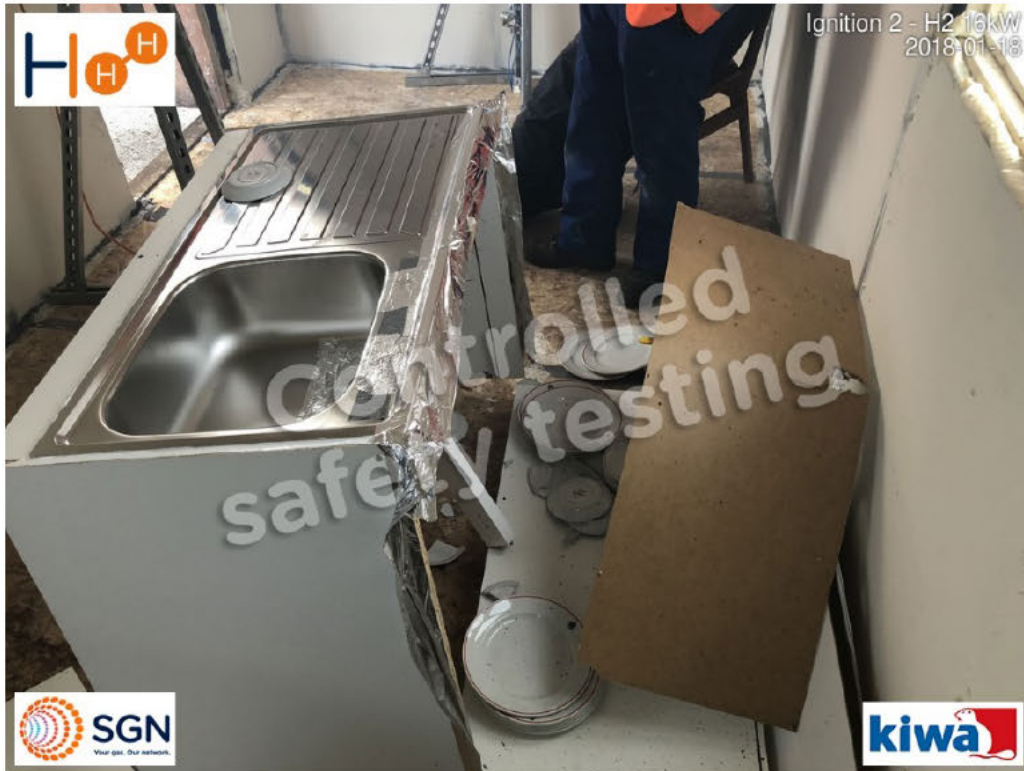
The damage to the FIB contents was surveyed after each ignition and the findings are shown in Table 9. In the methane ignitions, the sink cupboard did not open and the gas inside was not ignited, whereas in the hydrogen ignitions the door was knocked opened sufficiently to cause ignition of the gas inside the cupboard and then the collapse of the cupboard (Figure 15).

Figure 15: Close-up of sink damage after ignition 2 (16kW hydrogen)
Crockery was only damaged by landing on floor after collapse of cupboard and not by ignition itself

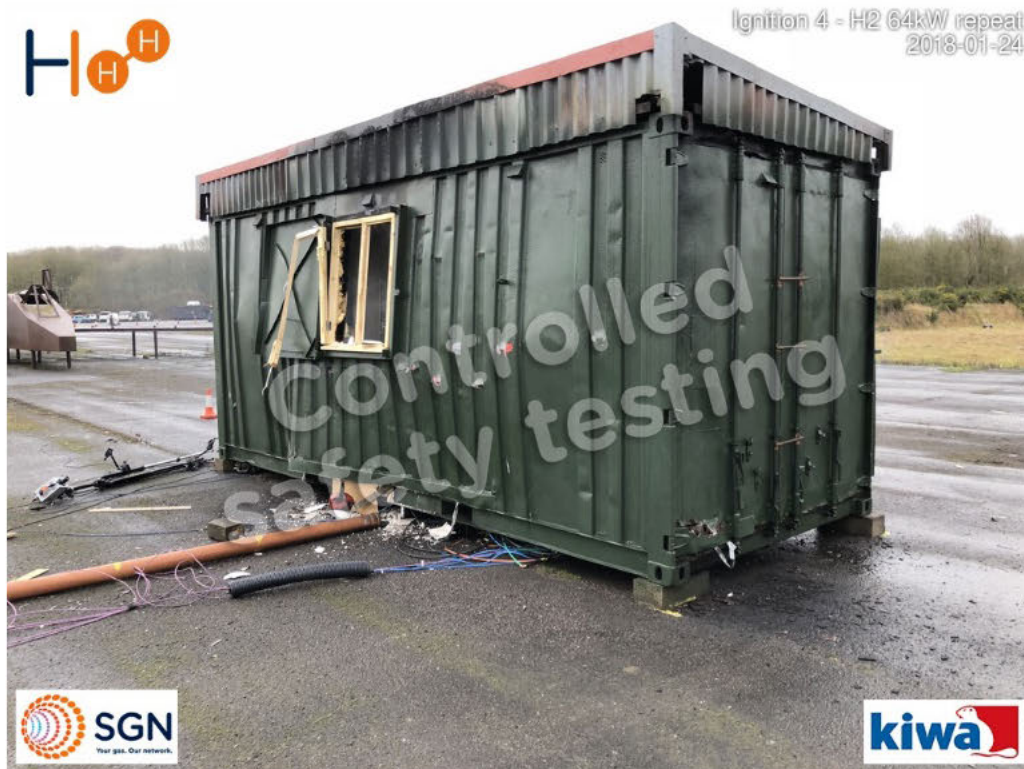
Damage to the building fabric was minimal in the ignitions at lower concentrations. At higher concentrations there was damage to the plasterboard in the FIB (this would have allowed additional pressure relief) and in ignition 4 there was structural damage to the metal skin of the FIB (Figure 16). Table 10 summarises the observations.

Figure 16: Damage to FIB wall near sink cupboard after ignition 4 (64kW hydrogen with detonation)

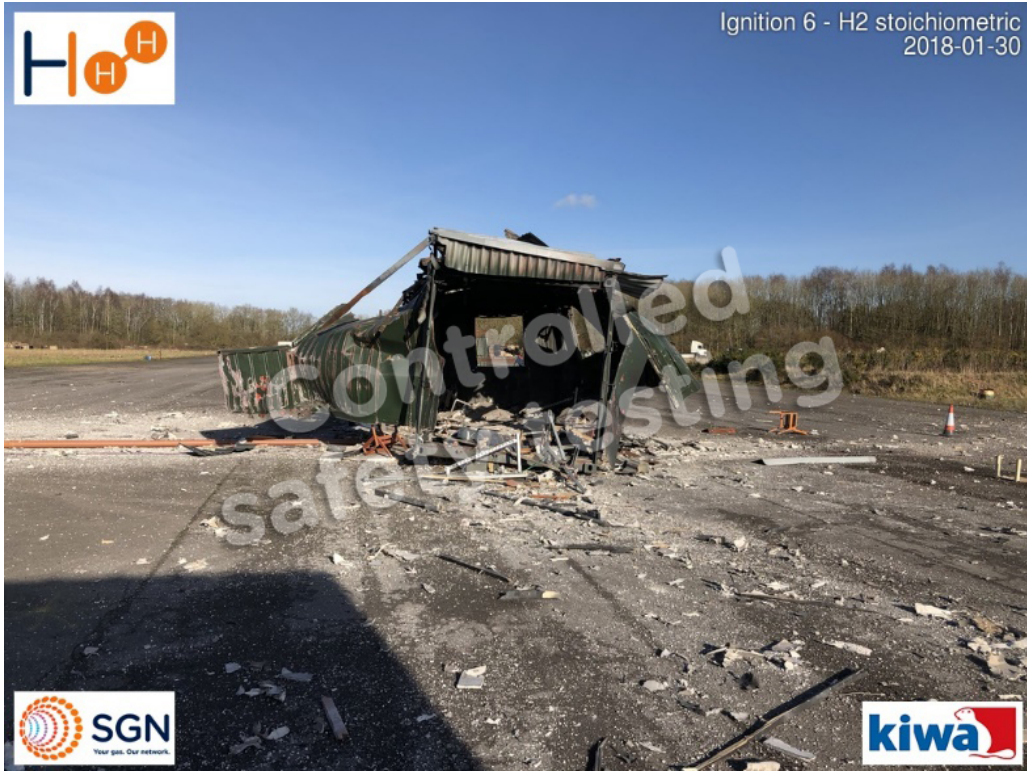
*Figure 20: View of end wall of FIB after ignition 6 (100kW hydrogen)
The FIB's metal doors have been torn apart from FIB frame during the explosion.
Debris from inside FIB is visible on the ground outside.*

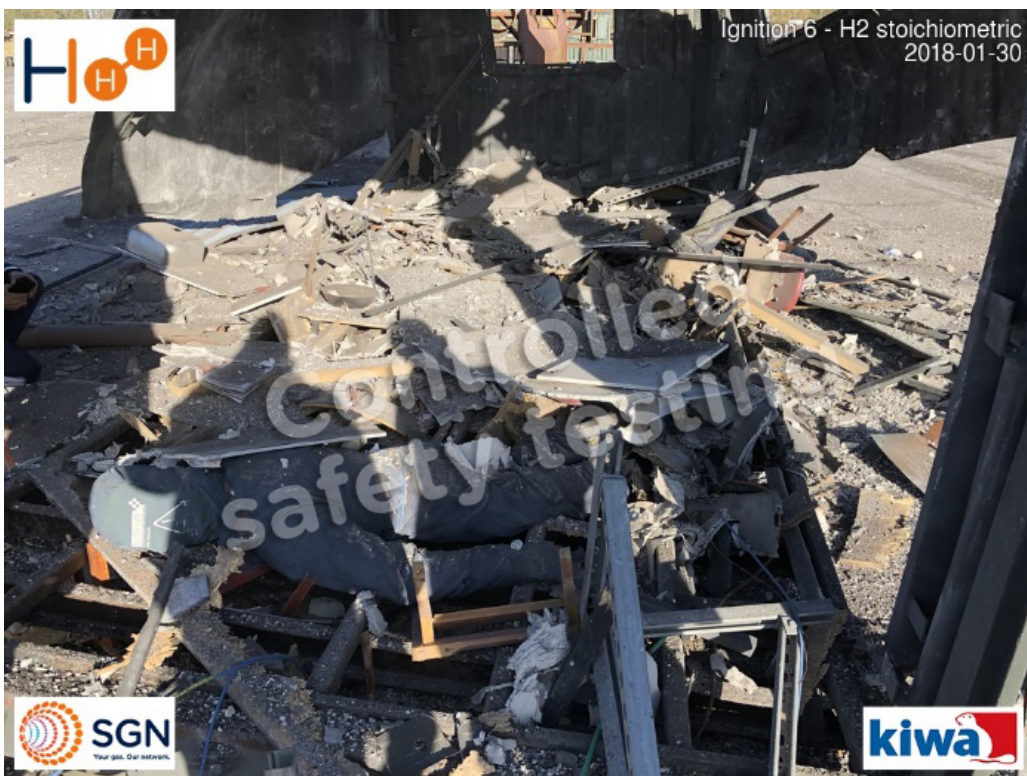
Inside the FIB there was also severe damage. All the furniture was destroyed, and the metal sink was misshapen. The dummies were knocked to the floor and covered in debris (Figure 27).

Figure 21: Close up of damage inside FIB showing collapsed ceiling, walls and floor, and 30kg dummy and broken chairs

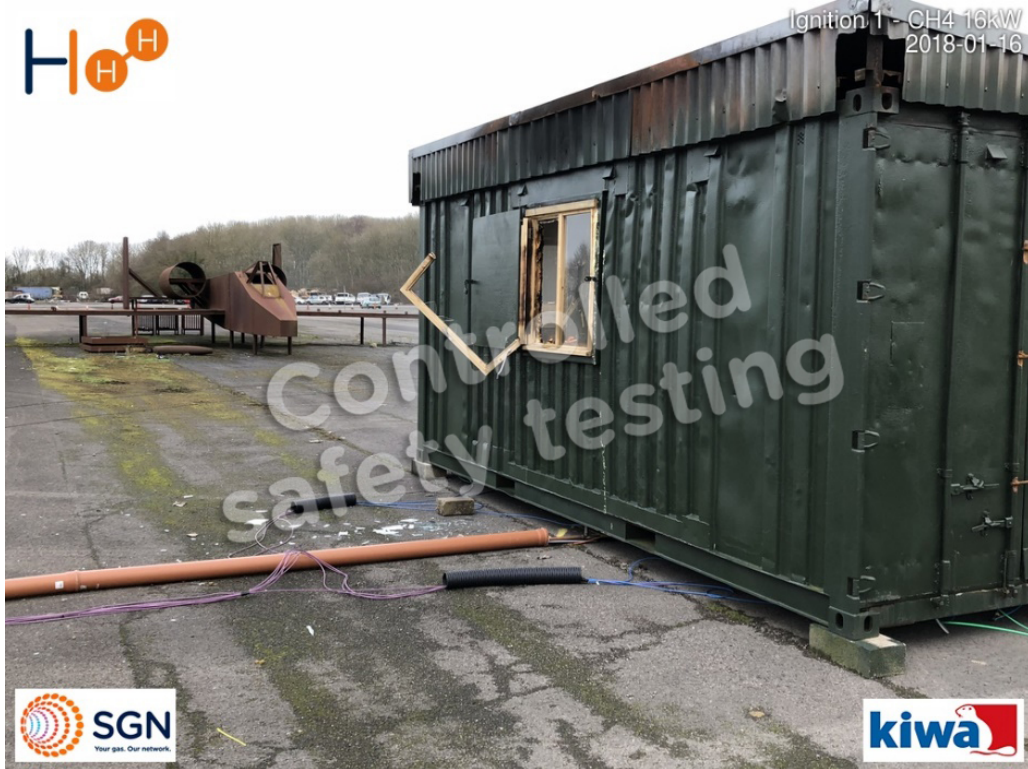
Figure 27: Outside view of FIB showing window above sink with detached frame and glass fallen out. Flames from newspaper on fire on table top just visible through window

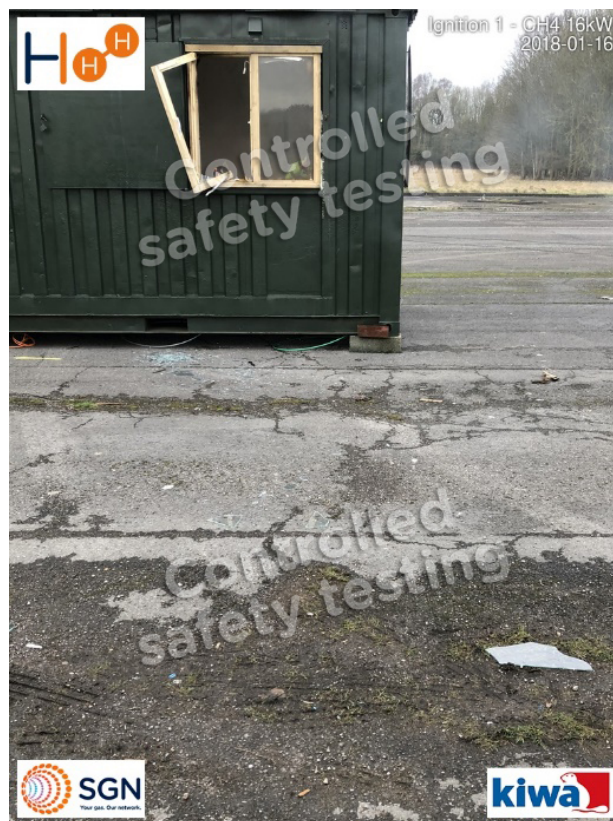
Figure 28: Side window at table end of FIB, showing furthest distance to glass fragment. Remaining glass fell out of frame and smashed on ground

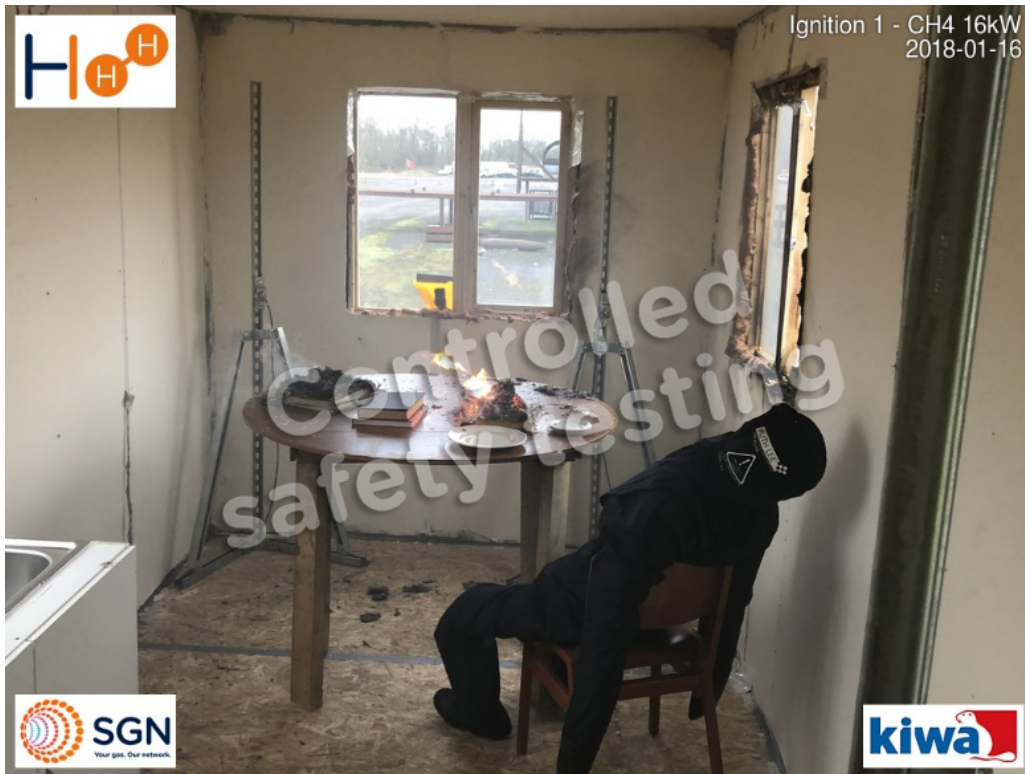
Figure 29: Inside view of FIB showing newspapers on fire on table top. Scorch marks visible around windows are from non-fire retardant insulating foam

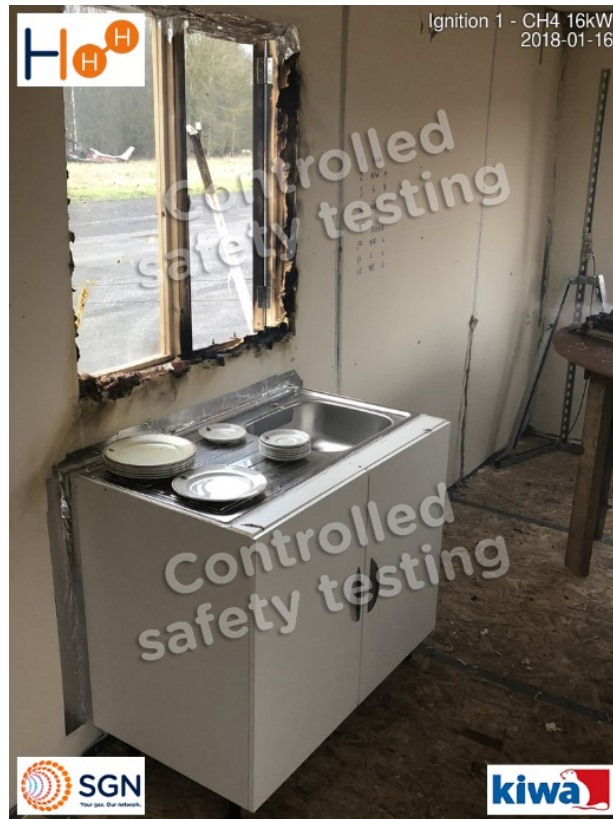
Figure 31: View of sink (undamaged) and blown out window frame

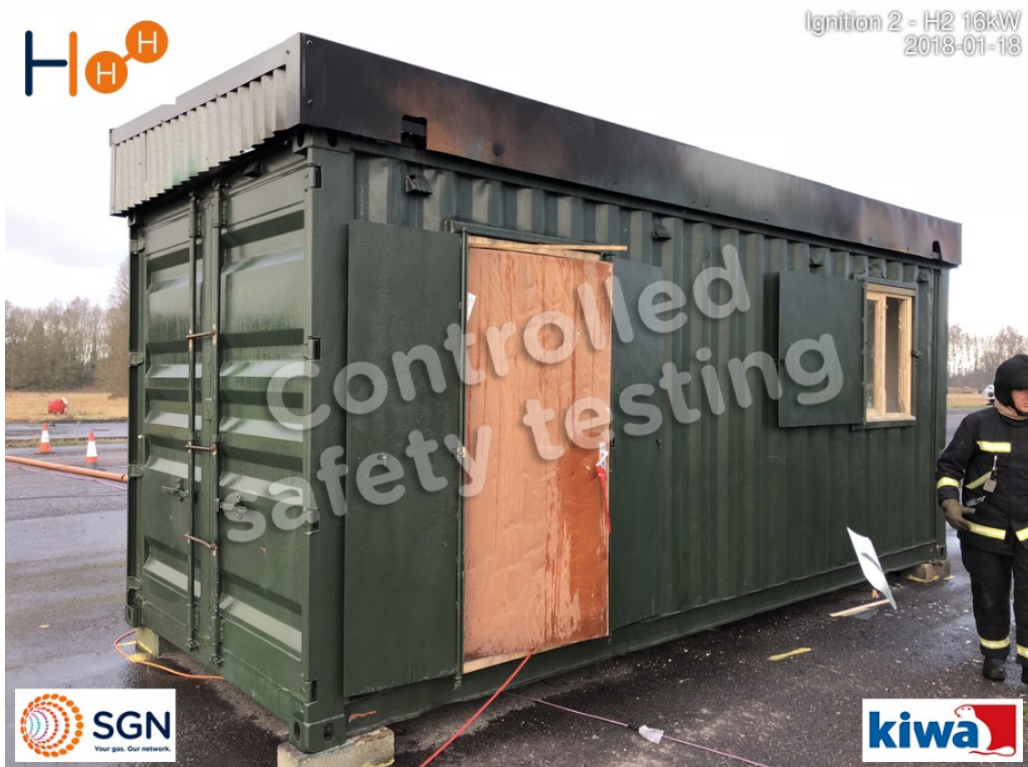
Figure 33: View of door with broken frame (but not completely blown out) and broken frame of side window

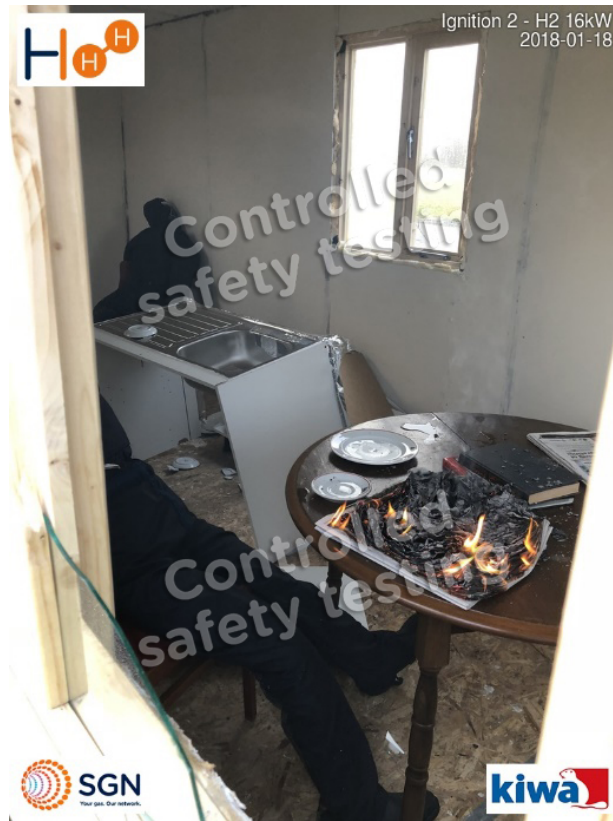
Figure 34: Inside view showing newspaper on fire and damaged sink cupboard

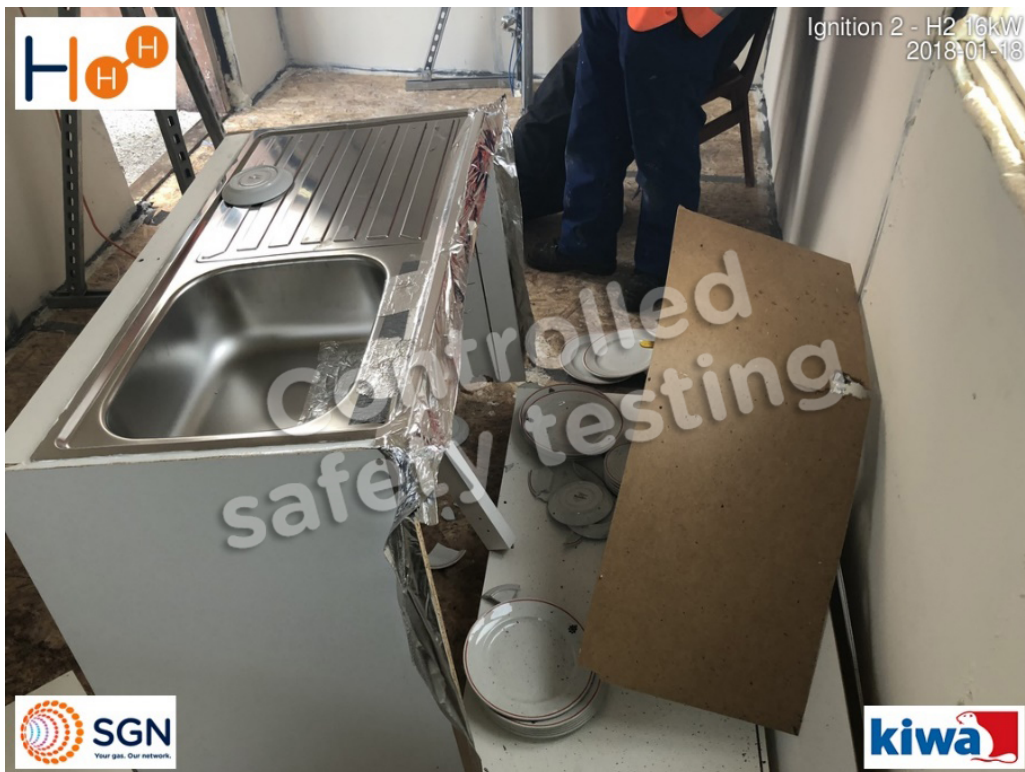
Figure 35: Close-up of sink damage (crochery was only damaged by landing on floor after collapse of cupboard and not by ignition itself)

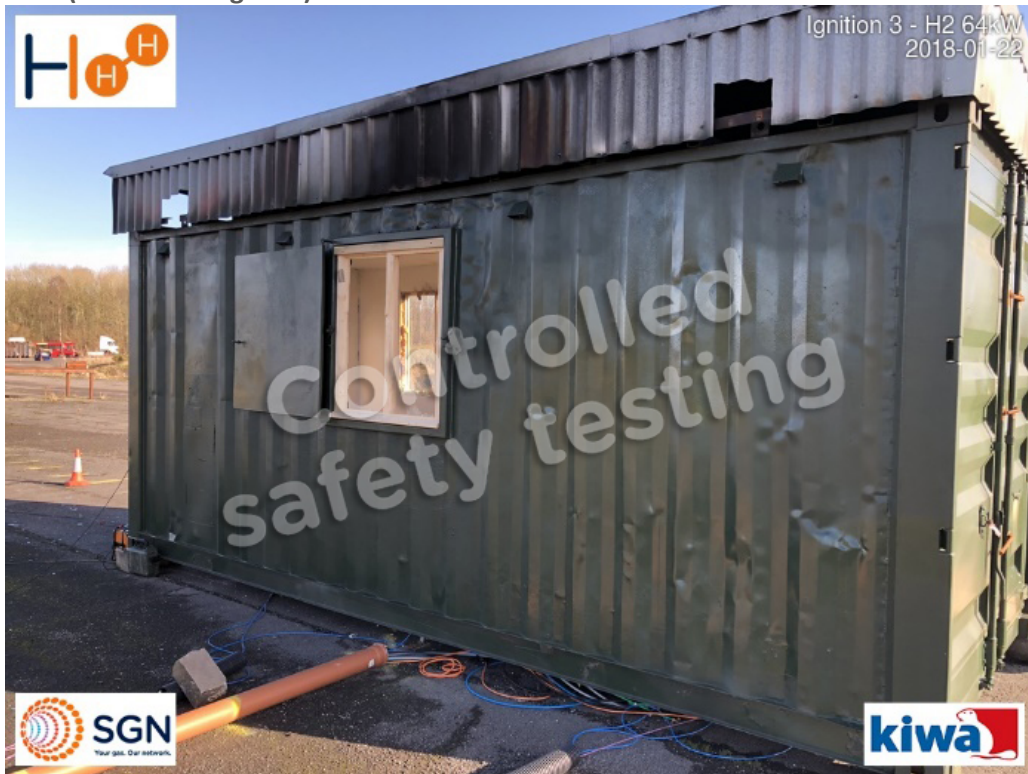
Figure 36: View of sink window showing blown out glass in both windows

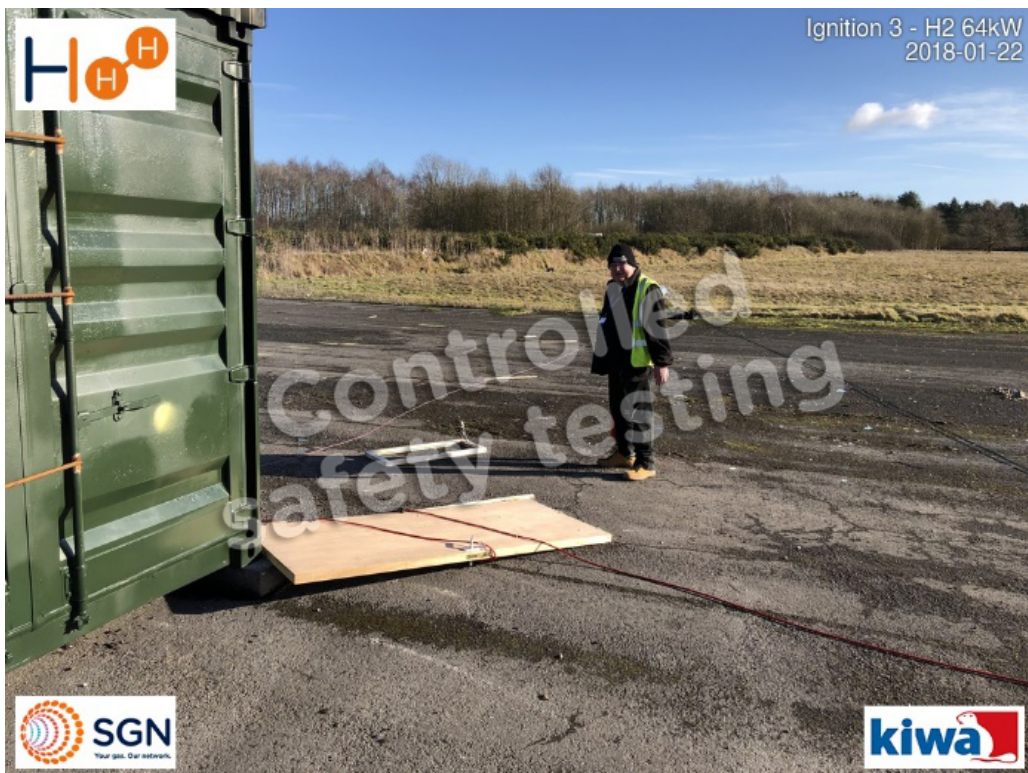
Figure 37: View of blown out door and side window frame (door was restricted from moving any further due to door opening mechanism)

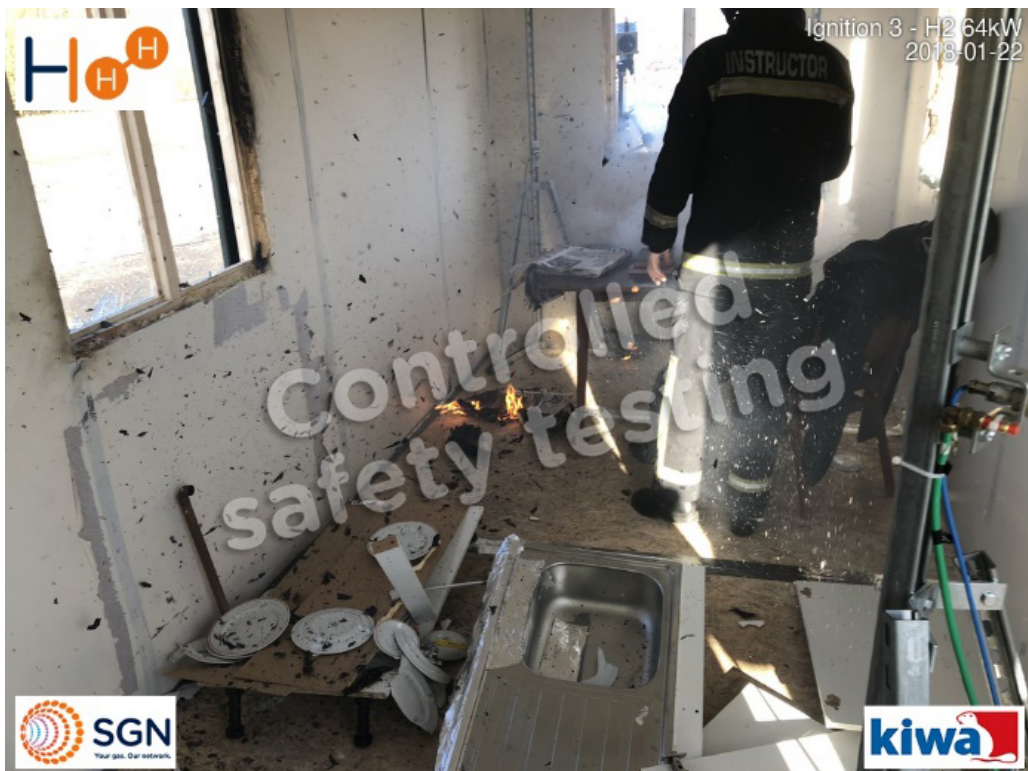
Figure 39: Inside view through doorway, showing blown out sink window and damage to sink cupboard (crochery was only damaged by landing on floor after collapse of cupboard and not by ignition itself)

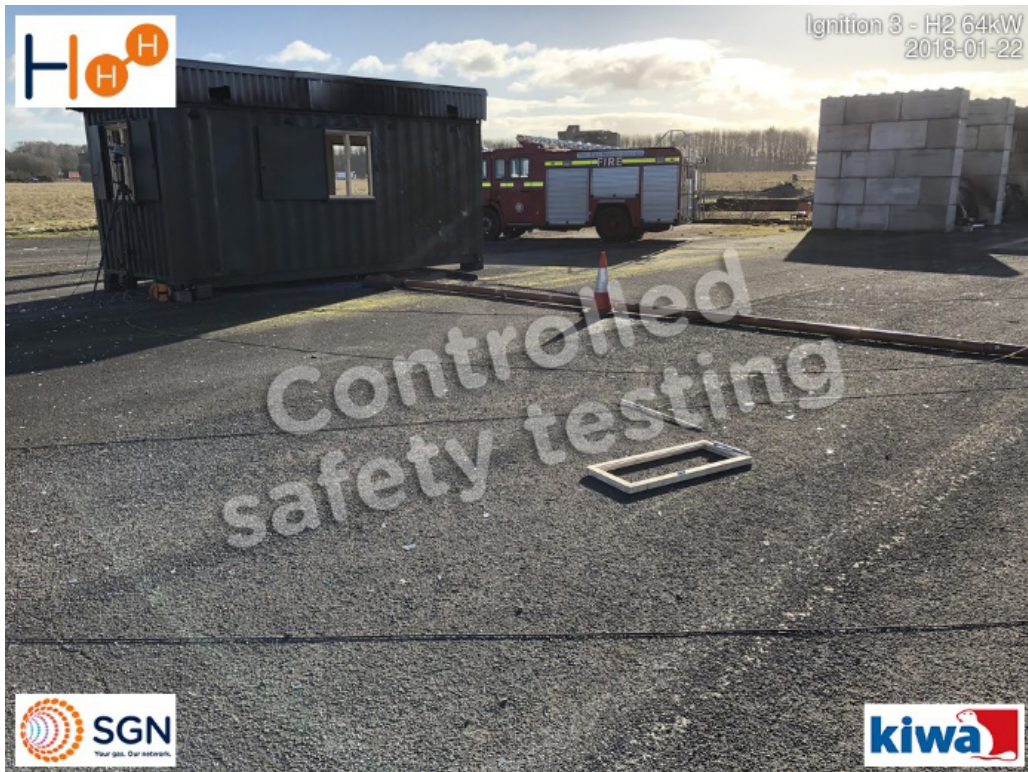
Figure 40: View of blown out sink window frame, approx. 10m from FIB

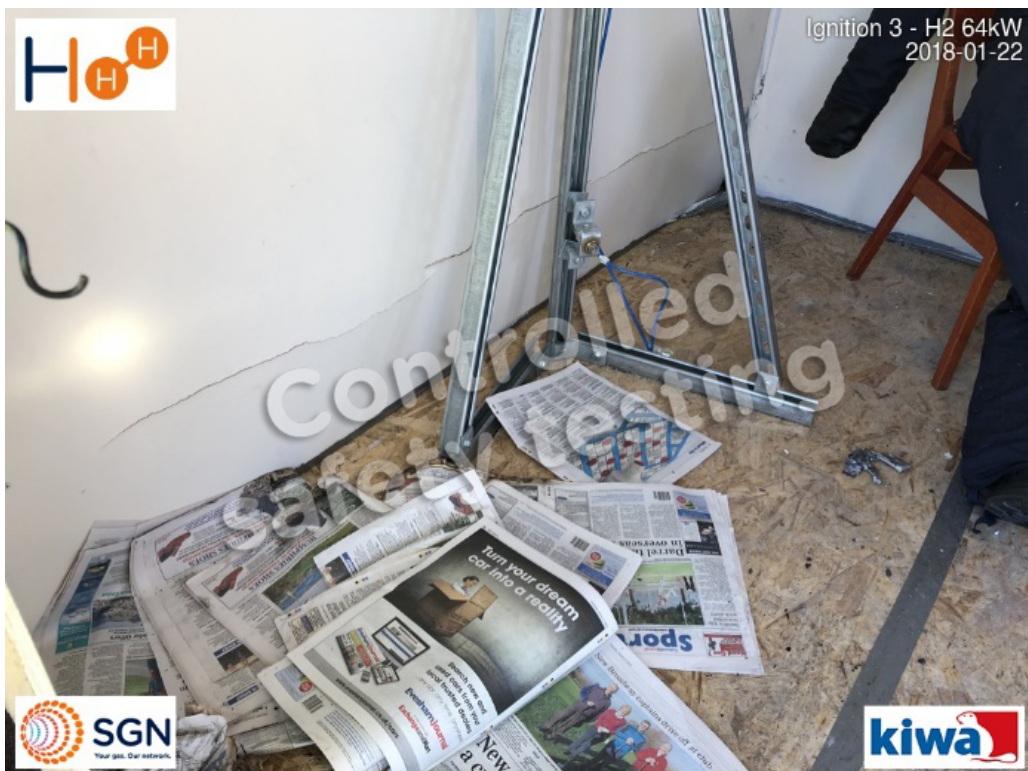
Figure 41: Damaged plasterboard at floor-level (approx. 30cm from ground and 2m long), indicating some pressure-relief was through the walls

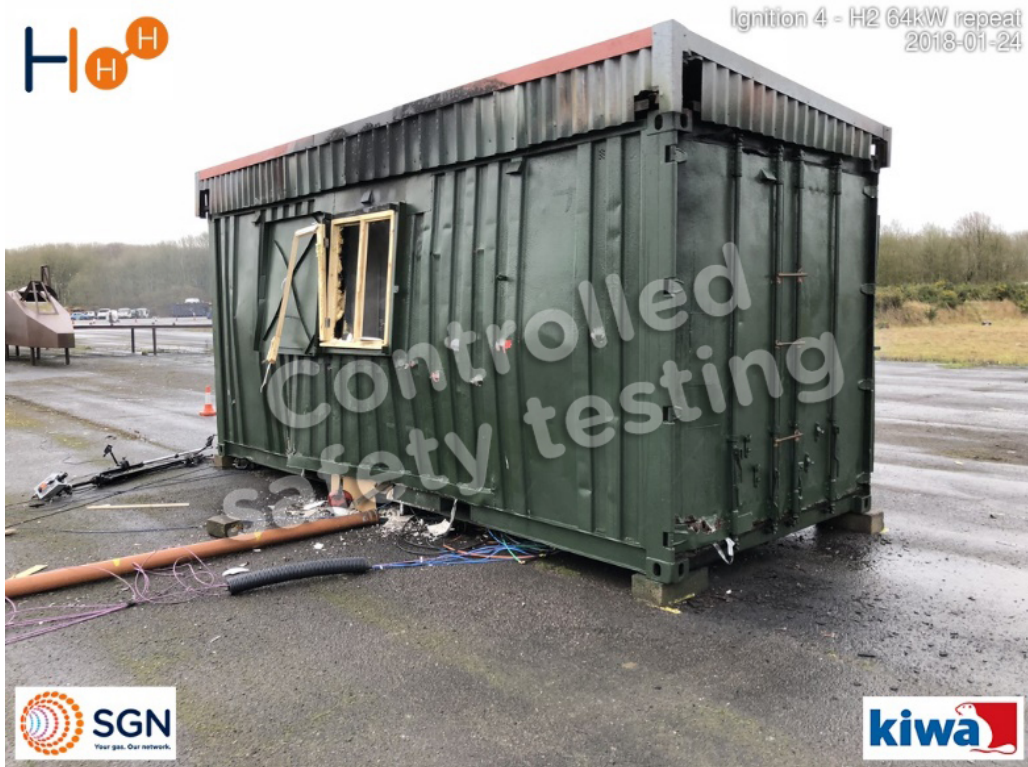
Figure 42: View of blown out sink window showing damage to FIB wall near sink cupboard

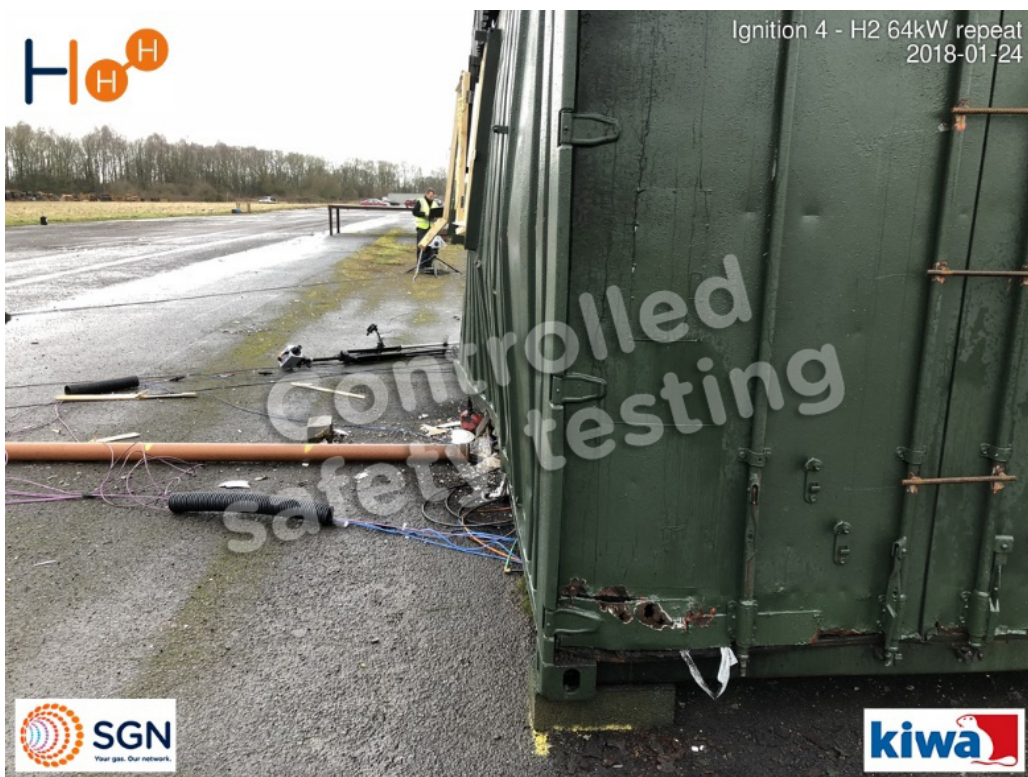
Figure 43: Side view of damaged FIB wall and damage to paint at bottom of end wall (caused by pressure-relief)

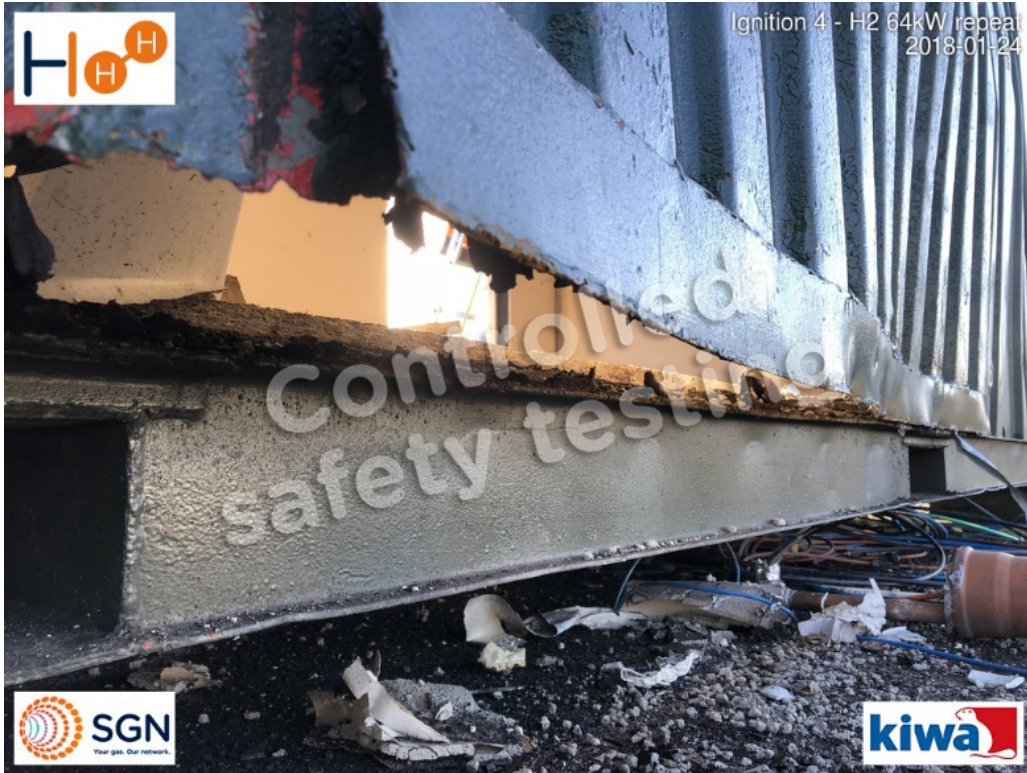
Figure 44: Close-up of damage to FIB wall showing 10-20cm gap in weld

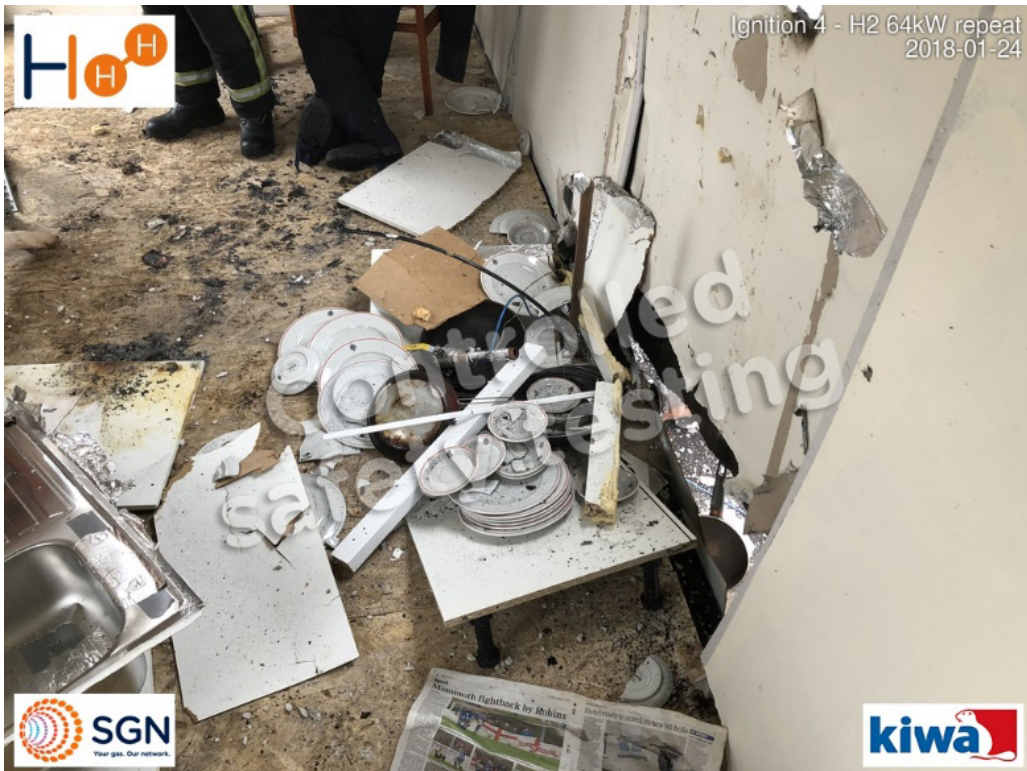
Figure 45: Close-up of damaged sink cupboard and damage to FIB wall

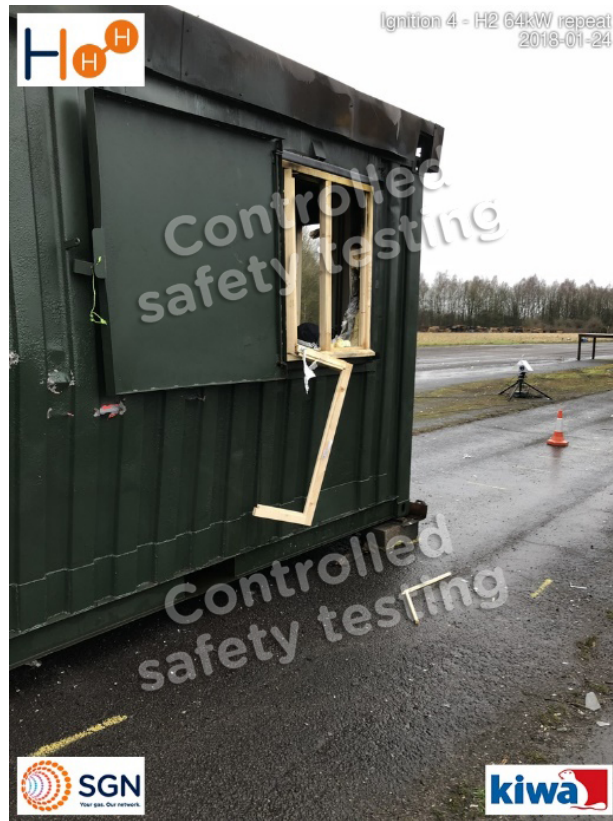
Figure 46: Outside view of damage to FIB shape on opposite side to sink cupboard, also showing blown out window

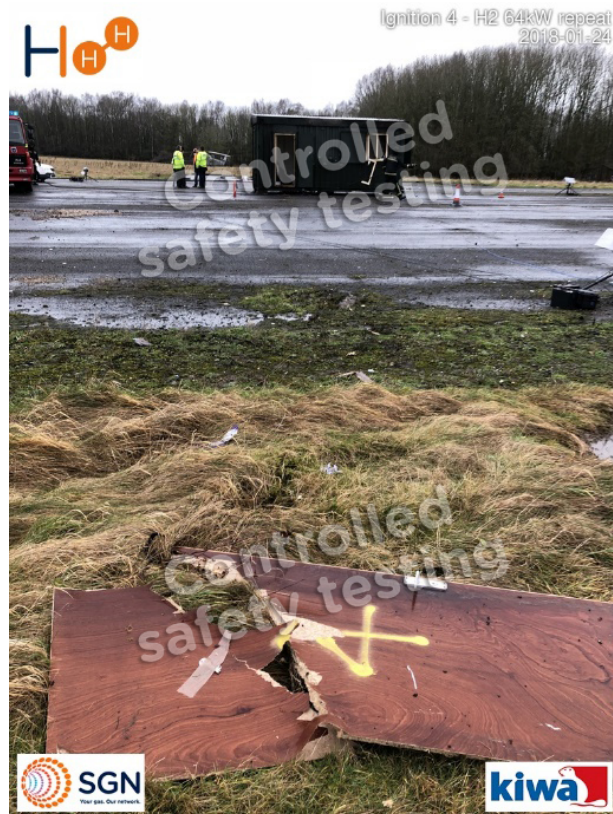
Figure 47: Blown out door approx. 25m from doorway

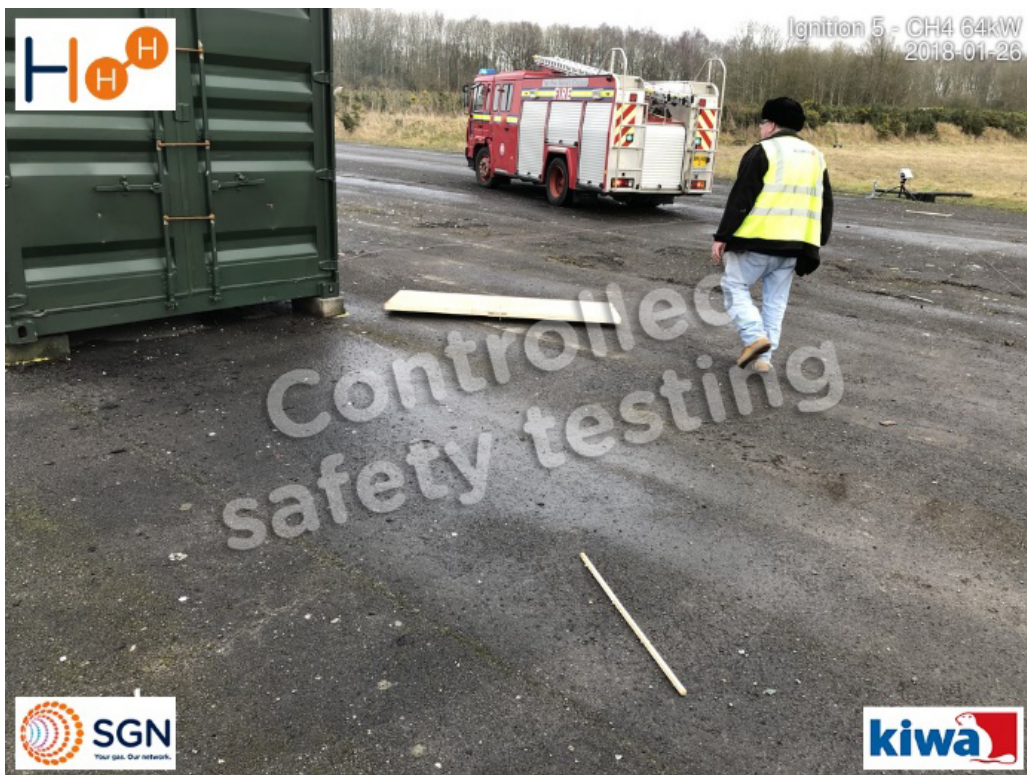
Figure 49: Blown out door and door surround (foreground)

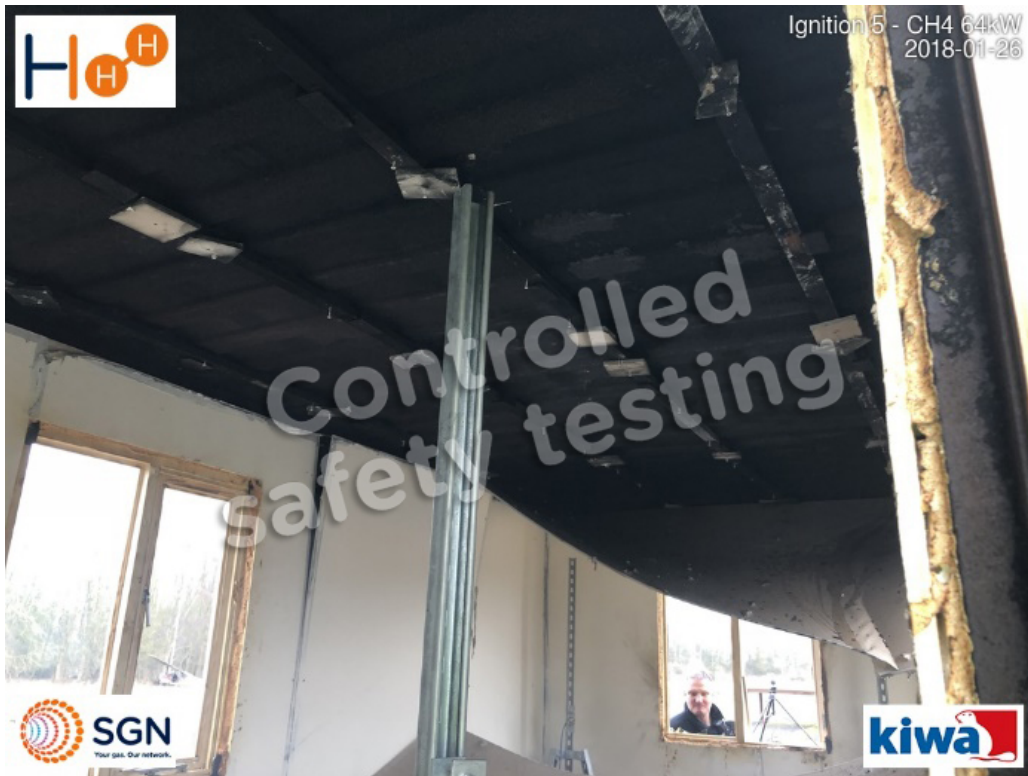
Figure 50: Internal view of FIB showing collapsed ceiling

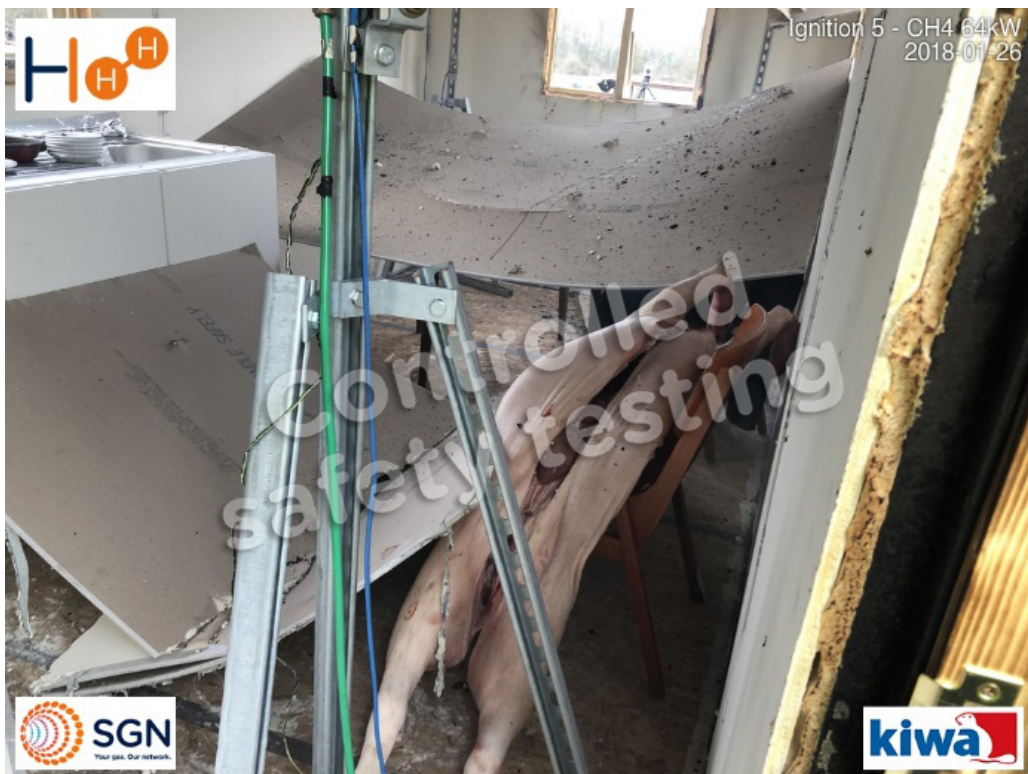
Figure 51: Collapsed ceiling in pig carcass

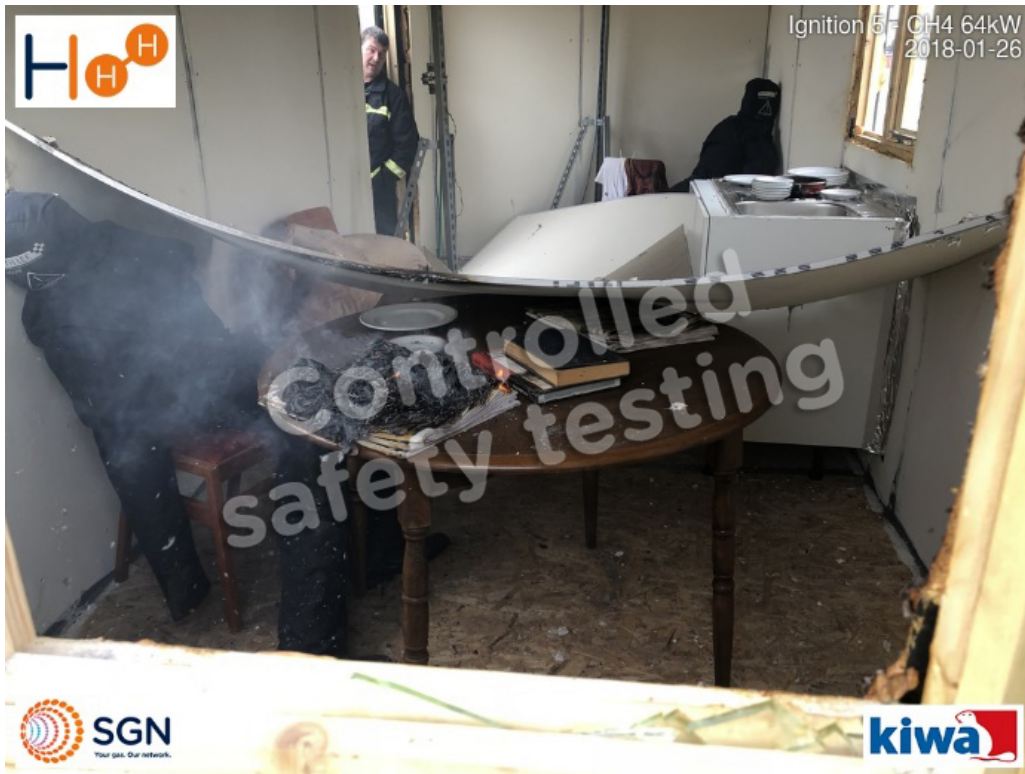
Figure 52: View of lit newspaper underneath damaged ceiling. Sink cupboard is in tact and gas inside did not ignite

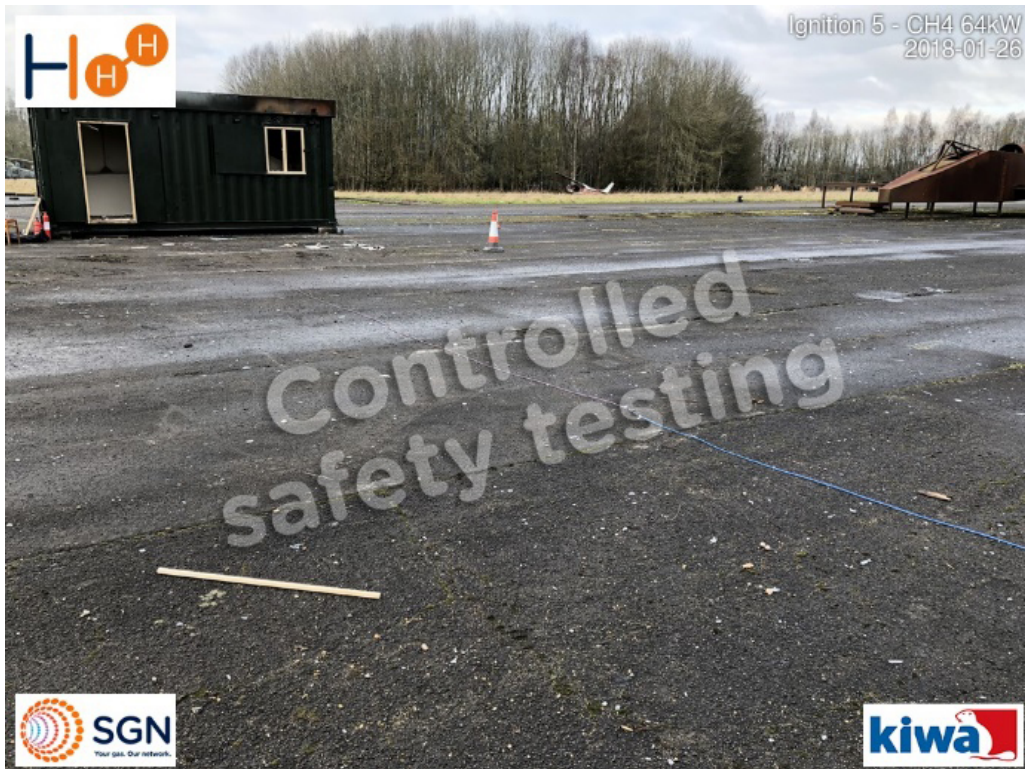
Figure 53: View of door/window frame debris approx. 15m from FIB
