Project final report

Investigation of the impact of ignition
of hydrogen and natural gas
accumulations in spaces in dwellings –
Phase 1
Kiwa 30875

10 August 2018

A report by Kiwa Ltd.

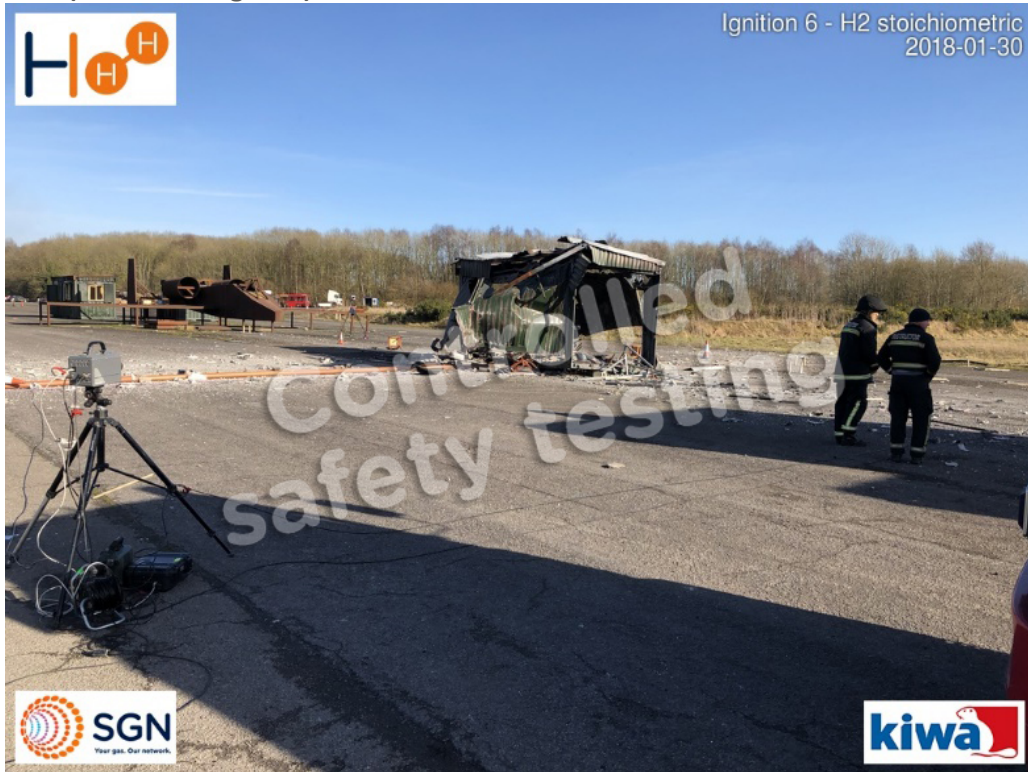
Figure 54: Wide view of severely damaged FIB and extent of debris on runway (approx. 25m in both directions)

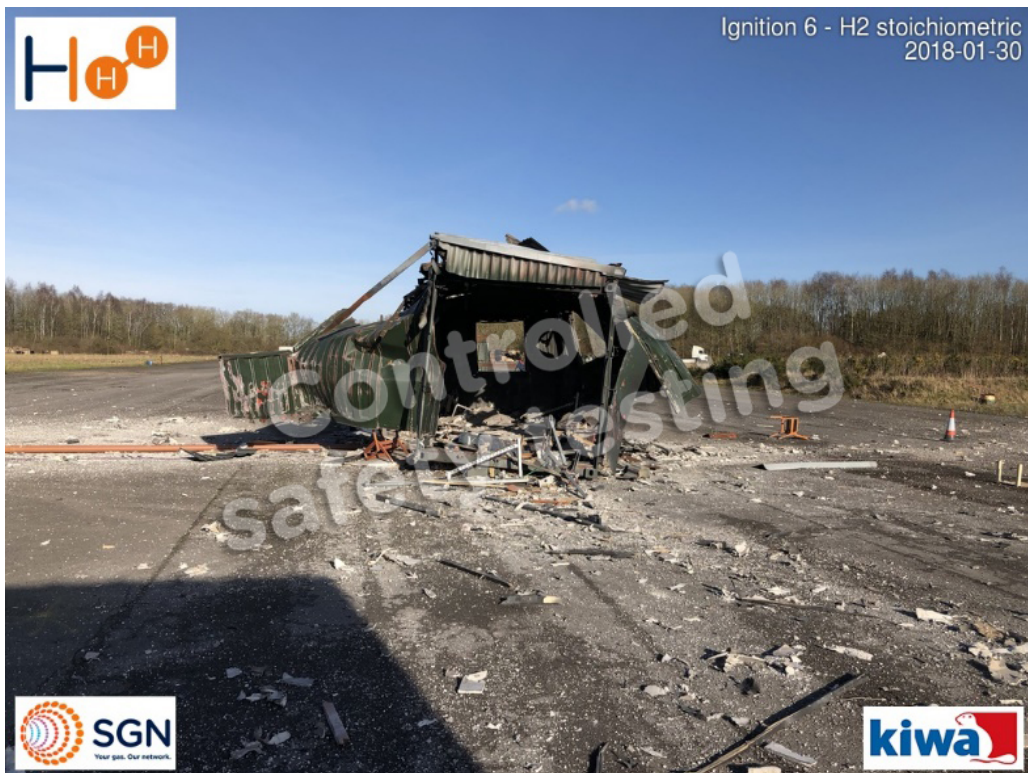
Figure 55: View of end wall of FIB (doors have been torn apart from FIB frame during explosion). Debris from inside FIB visible on the ground outside, including pressure measurement stand (centre)

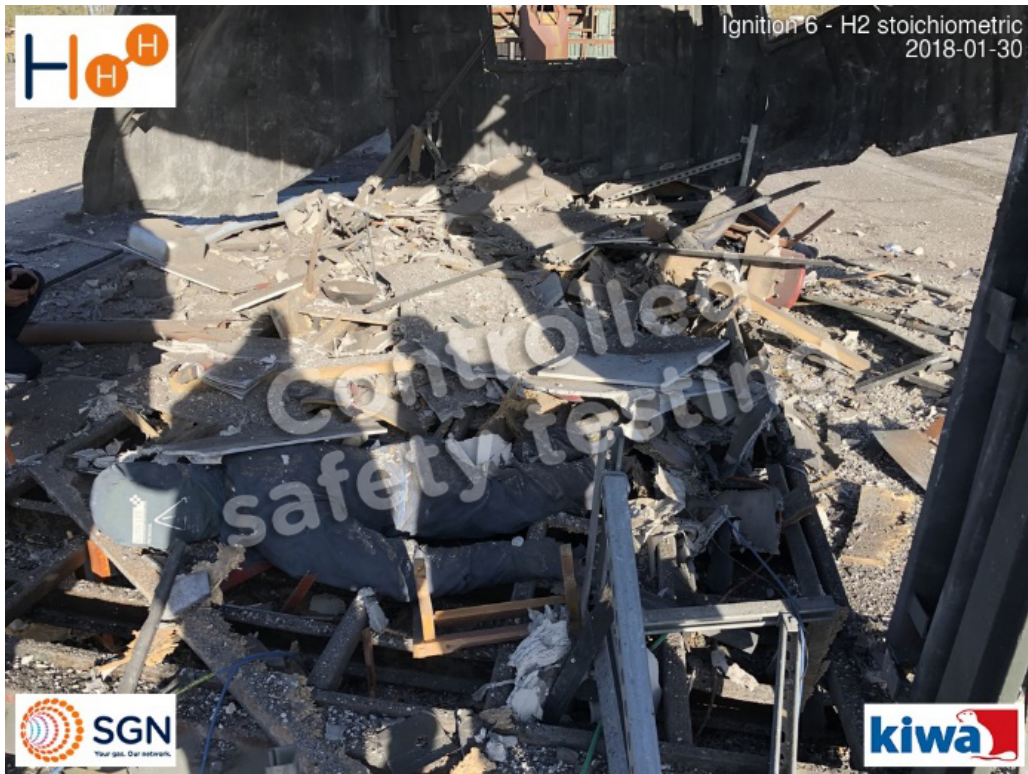
Figure 56: Close up of damage inside FIB showing collapsed ceiling, walls and floor, and 30kg dummy and broken chairs

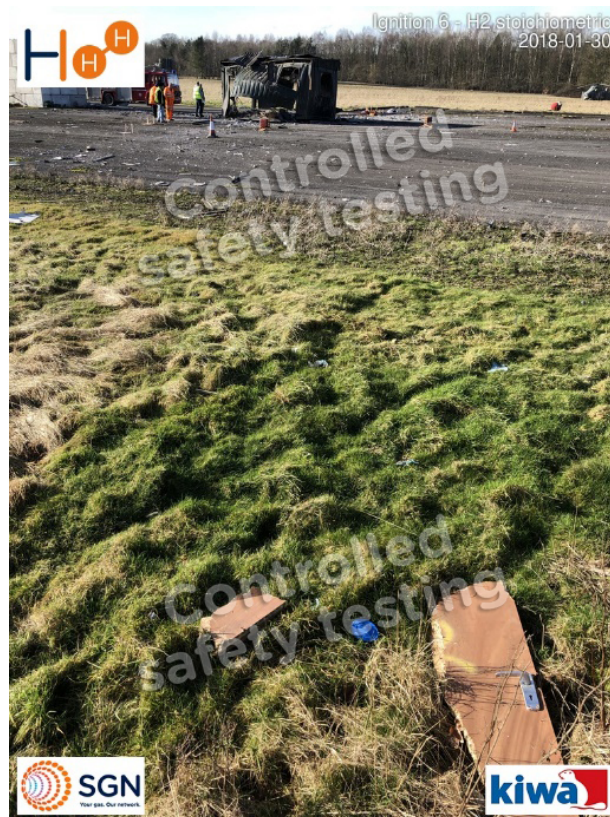
Figure 57: Door debris approx. 30m from FIB

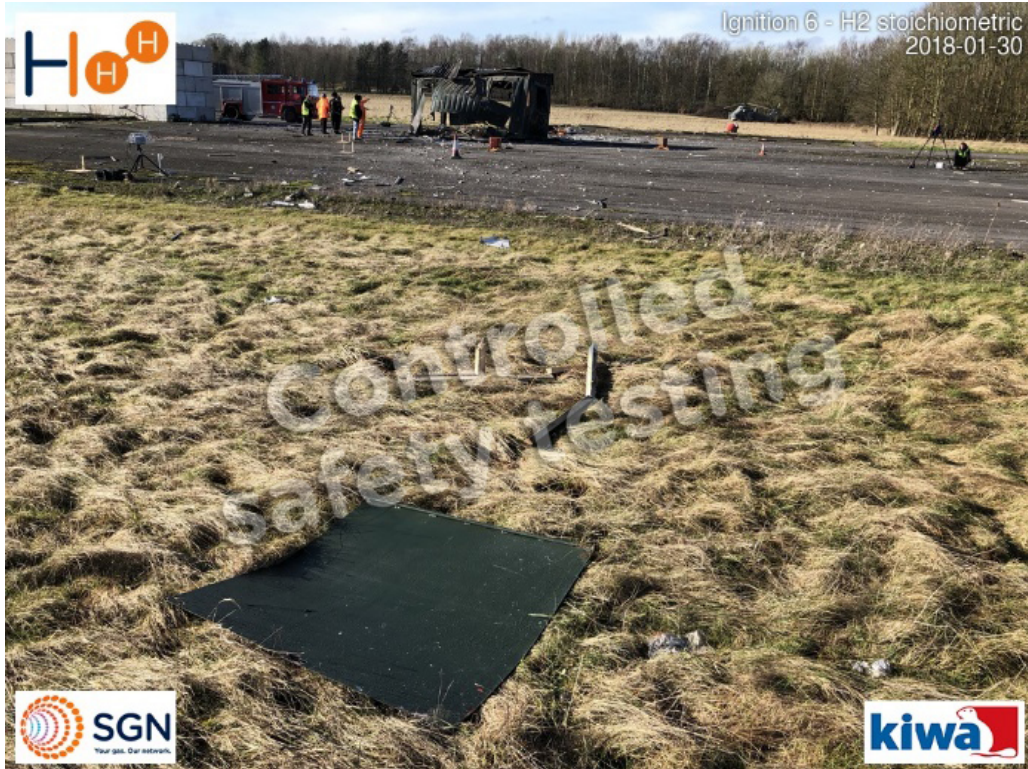
Figure 58: Window frame debris (background) and FIB debris (foreground) approx. 40-50m from FIB

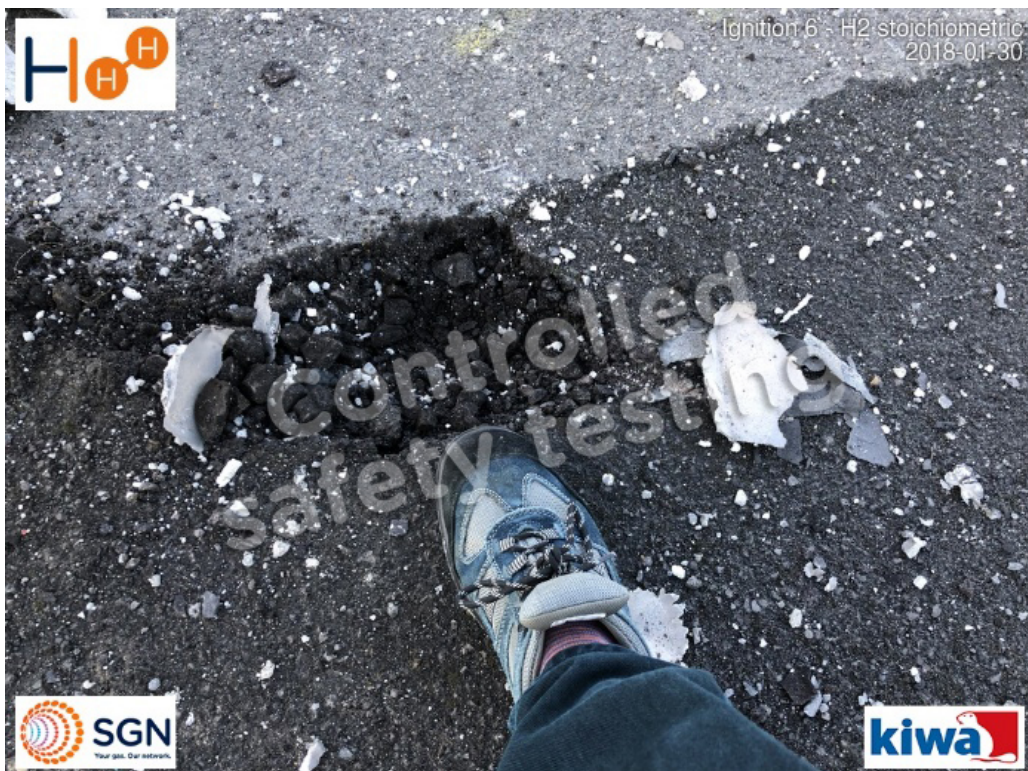
Figure 59: Damage to tarmac approx. 10m from end wall of FIB
