## Driving awareness of CO; <u>a data-driven strategy</u>

January 2018

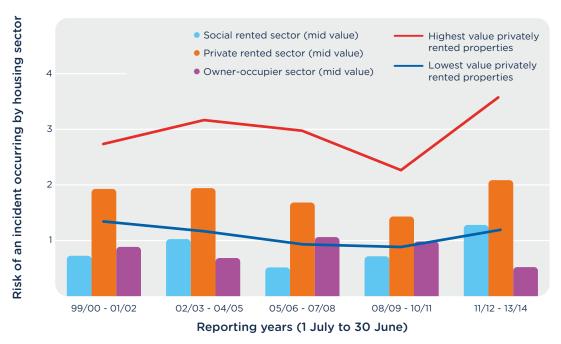
#### Historical risk of an incident by UK housing sector

This DIDR graph shows the risk associated with the private rented sector. It shows the risk has historically remained fairly constant at around twice that in any other housing sector.

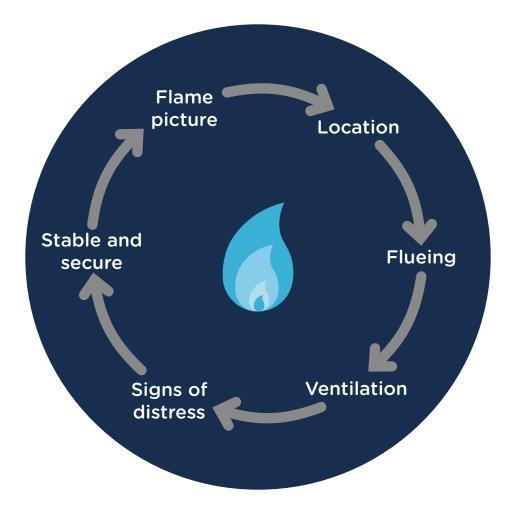
#### Unsafe situations visual risk assessment diagram

Information relating to appliance type, location and condition was captured at each property. A visual risk assessment was also carried out on every appliance in accordance with the Unsafe Situations Procedure.

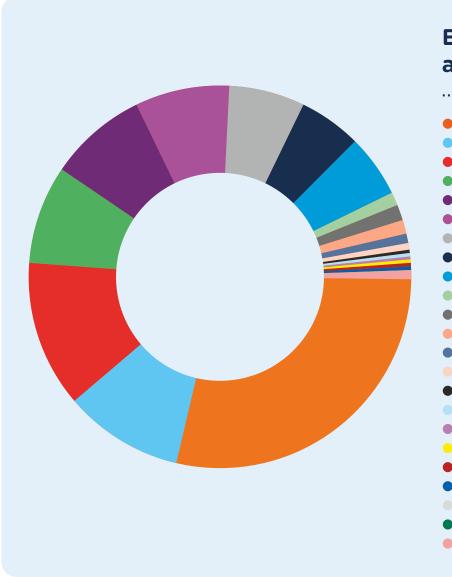
## Breakdown of appliance type

We grouped the inspected appliance data into appliance categories (central heating boilers, domestic cooking, space heating, commercial cooking, water heating, and other), and then sub-divided it by appliance type as shown overleaf.

- Combination boiler: 3,092 (28.5%)
- Regular/system condensing: 1,076 (9.9%)
- Built in hob: 1,347 (12.4%)
- Cooker slot in: 926 (8.5%)
- Back boiler unit: 885 (8.2%)
- Inset live fuel effect: 877 (8.1%)
- Regular/system non-condensing: 685 (6.3%)
- Decorative fuel effect fire: 574 (5.3%)
- Radiant: 568 (5.2%)
- Range: 144 (1.3%)
- Other: 133 (1.2%)
- Cooker eye level grill: 115 (1.1%)
- Gas fire (LFE closure plate): 104 (1.0%)
- Hob: 50 (0.5%)
- Oven: 38 (0.4%)
- Built in oven: 32 (0.3%)
- Tumble drier: 32 (0.3%)
- Fryer: 25 (0.2%)
- Built in oven and grill: 25 (0.2%)
- Warm air heater: 22 (0.2%)
- Instantaneous water heater: 17 (0.2%)
- Storage water heater: 14 (0.1%)
- Other: 61 (0.6%)
