Project final report

Investigation of the impact of ignition
of hydrogen and natural gas
accumulations in spaces in dwellings –
Phase 1
Kiwa 30875

10 August 2018

A report by Kiwa Ltd.

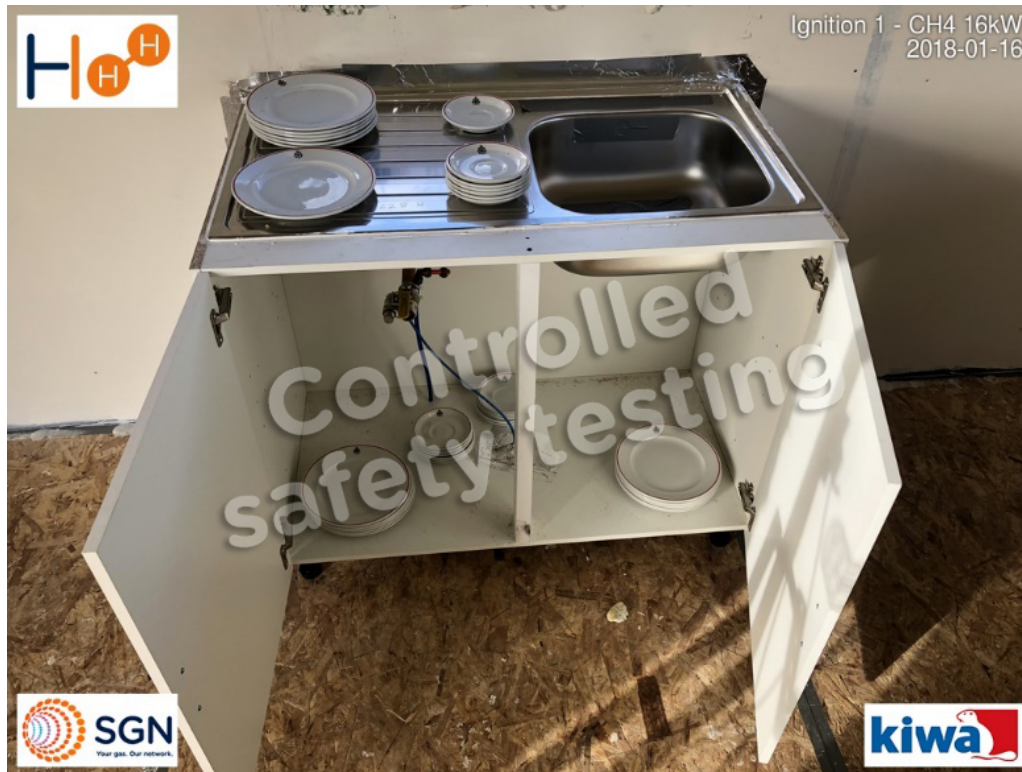
Figure 26: Close-up of cupboard, showing plates on top and plates inside. Gas injection point and pressure sensor are mounted at mid-height in the cupboard (in later the two final H_2 tests, additional saucepans were placed in the cupboard)

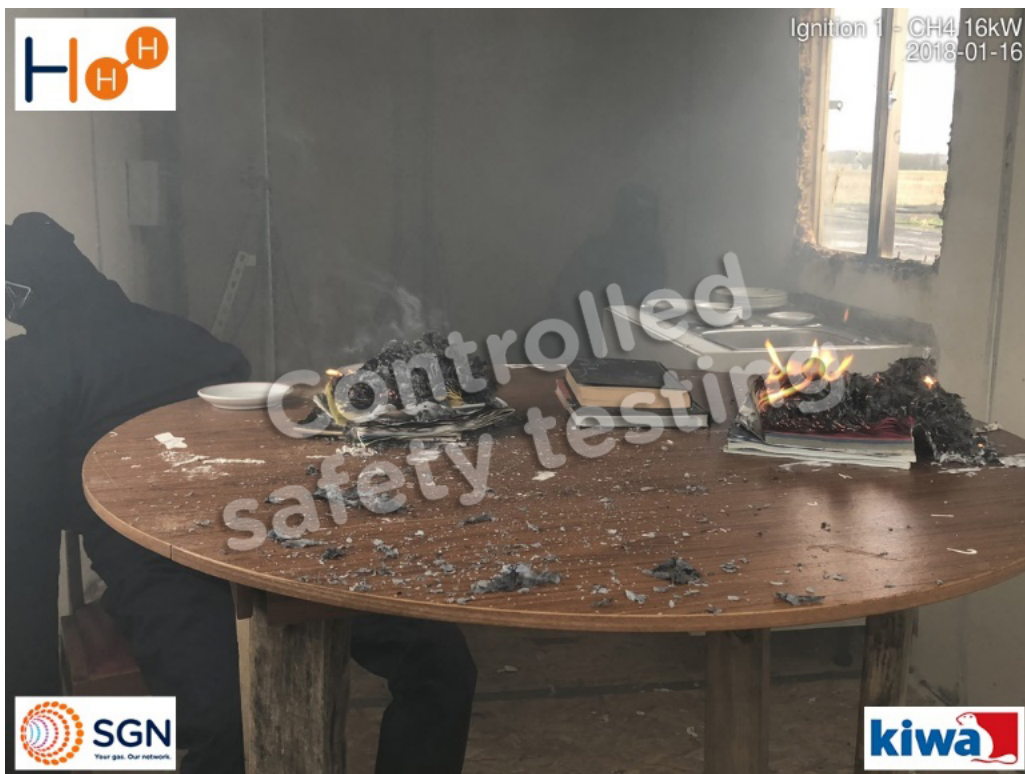
Figure 30: Close-up of books and newspapers on table top

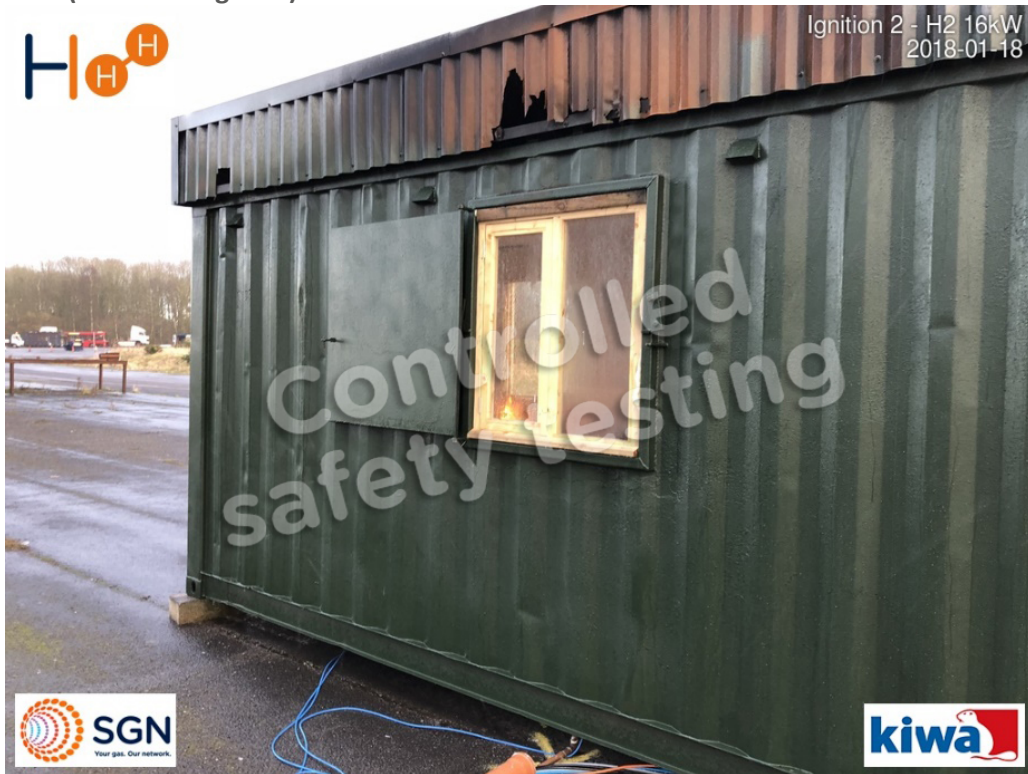
Figure 32: Outside view of FIB showing window above sink (undamaged but with condensation). Flames from newspaper on fire on table top just visible through window

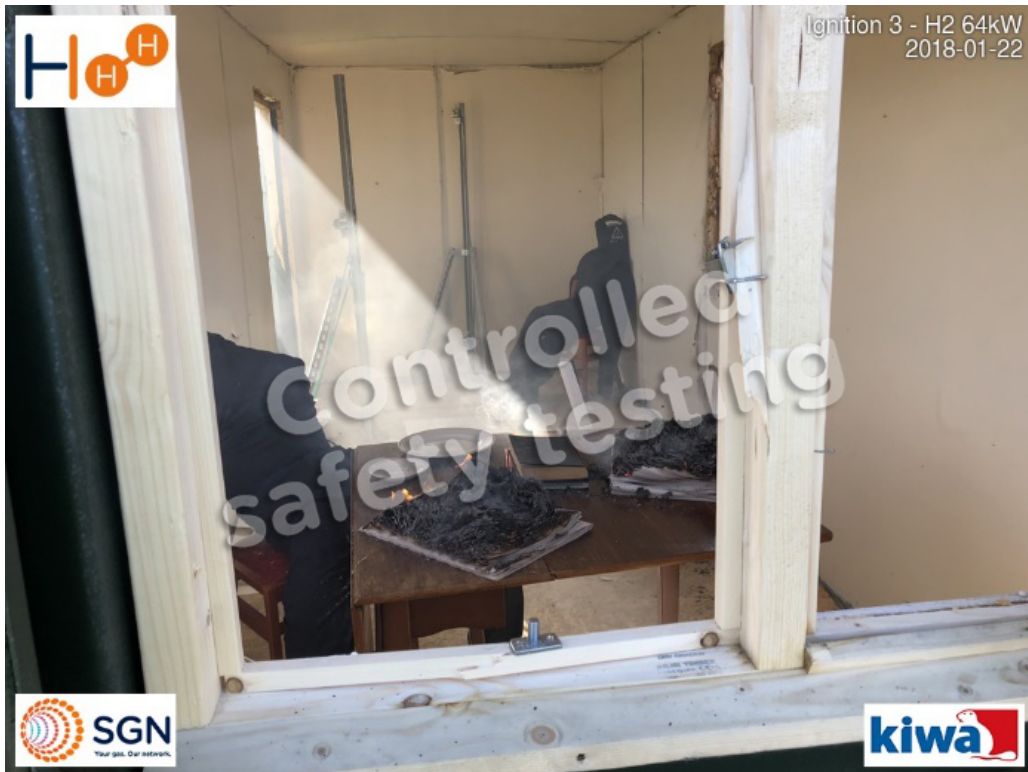
Figure 38: View through blown out end windows showing newspapers on table top

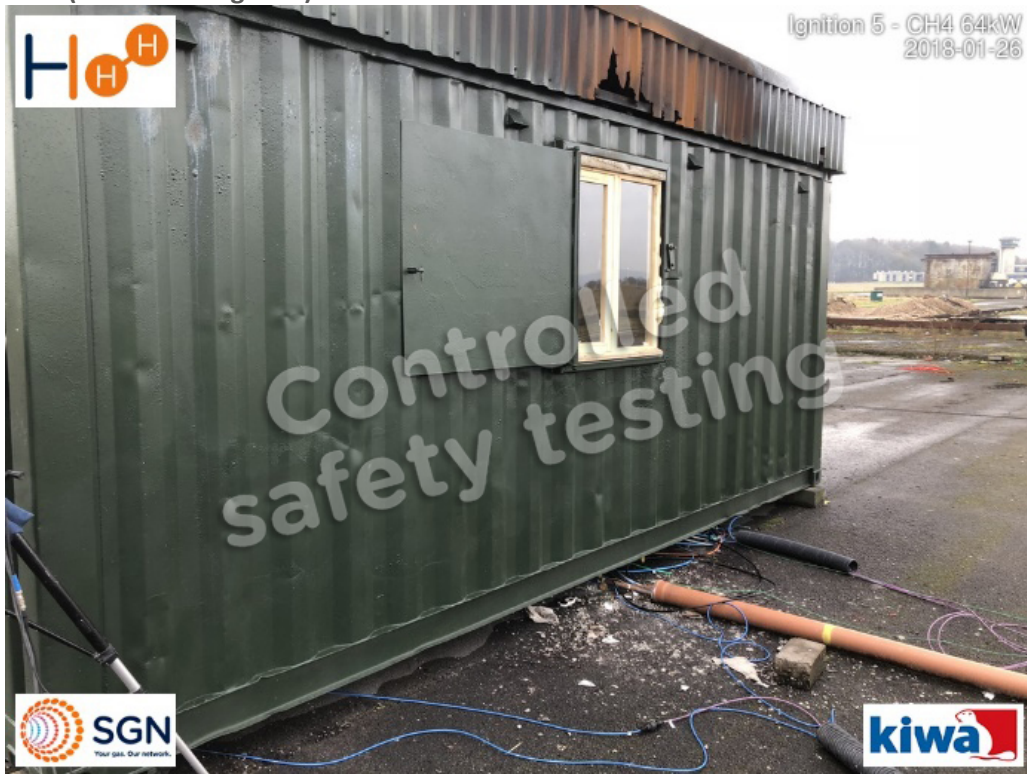
Figure 48: View of sink window showing no damage

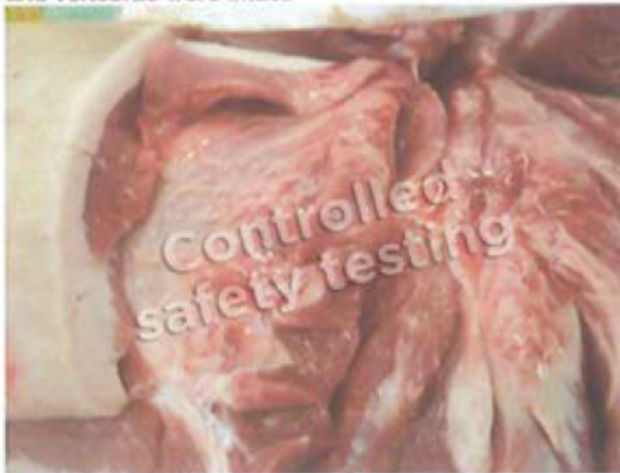
Fig 1.

Fig 1 (KIWA A): No blast-related lesions were detected of the skin surface. An area of mild subcutaneous and muscle oedema was present over the lateral aspect of the right shoulder (Fig. 1) and right stifle joint. These were interpreted as resulting from the carcass lying in lateral recumbency, right side down (rather than suspended from a hook). No other lesions were detected in limb, flank, paravertebral or head muscles. All limb bones, ribs and vertebrae were intact.

Fig 1: oedema
over right shoulder

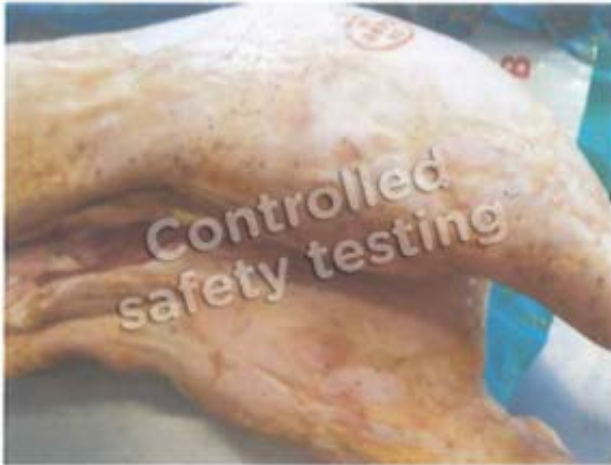
Fig 2.

A spattering of small (<1mm diameter) black particles was evident on the skin surface of the ventral abdomen, inner thighs (Fig 2) and right side of the neck/face. These were easily rubbed off and the underlying skin showed no scorch marking. These particles were interpreted as being carbon-based.

Carbon particles on ventral abdomen and hindlimb

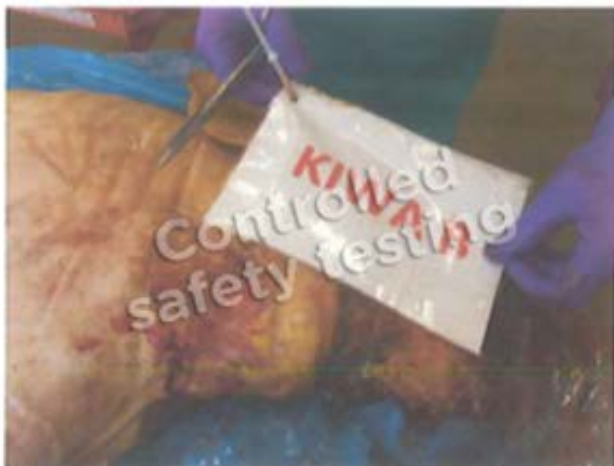
Fig 3.

An area of skin of the ventral neck was (discoloured) (Fig. 3) and localized muscle at the incision made in the abattoir for evisceration was also discoloured (darker than expected). However but there was no pathology of deeper skin layers or of muscle tissue below the exposed muscle surface. This discoloration may be artefact (bleeding and bruising does not occur after death) or, in the case of the muscle, reflect exposure to heat.

Discoloration of ventral neck skin of pig 2
